# INCIDENT INVESTIGATION REPORT

Type of occurrence <b>Fall from elevation</b>			
Notice of incident number <b>2022188240006</b>	Incident outcome <b>Fatality (1)</b>	Date of incident <b>May 23, 2022</b>	
Location of incident <b>Warehouse construction site 5255 North Fraser Way Burnaby, B.C.</b>	Primary investigator <b>Danielle GETZIE</b>	Investigation file number <b>FSI-REG-2022-0053</b>	
Approved by manager, OHS Investigations <b>Andreas MENDEL</b>	Signatur	Date <b>September 13, 2023</b>	
PARTIES INVOLVED IN INCIDENT			
Employer	Name <b>Supermétal Construction Inc.</b>	Employer ID <b>91516</b>	Industry classification <b>722005 Steel Frame Erection, Repair, Painting, or Bridge Painting or Cleaning</b>
Worker		<b>Deceased</b>	Occupation <b>Ironworker</b>
Employer	Name <b>Beedie Construction Ltd.</b>	Employer ID <b>795795</b>	Industry classification <b>721028 Industrial, Commercial, Institutional or Highrise Residential General Contracting or Construction</b>

At a site where a three-level steel-frame warehouse was being built, ironworkers were installing bolts into the beams on the roof of the structure. One of the workers fell 16.8 m (55 ft.) to the ground and was fatally injured.

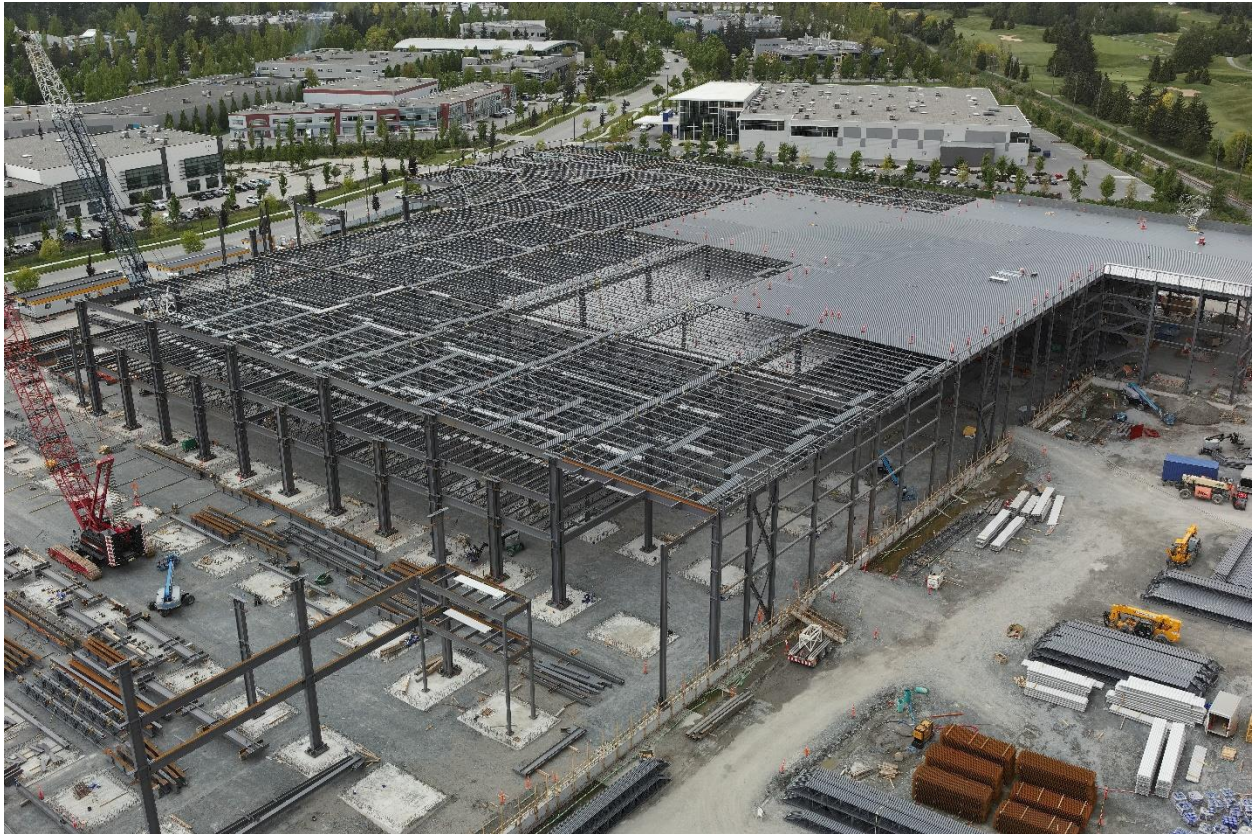
Workers at the incident site were working on a three-level, steel-frame warehouse that was at the structural steel framing stage of construction. (See Figure 1).

*Figure 1: Aerial view of steel-frame warehouse where incident occurred.*

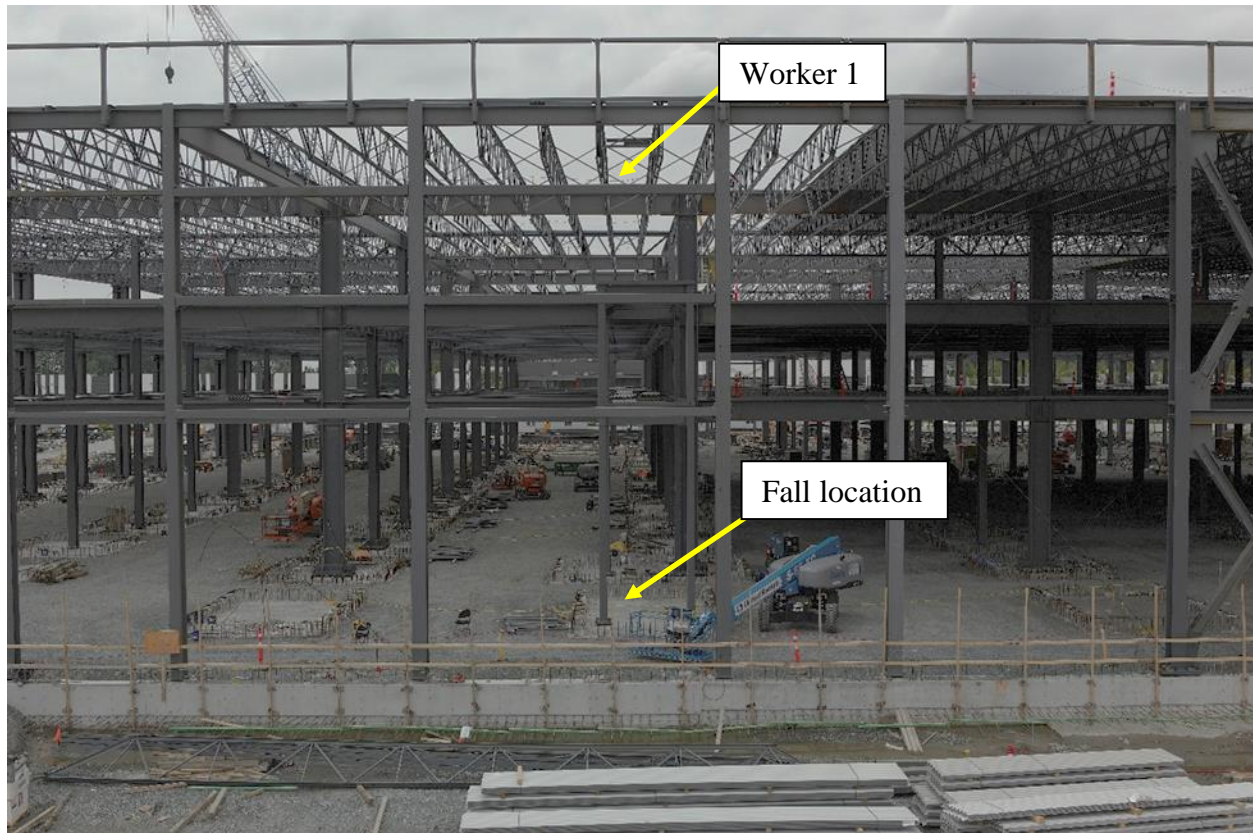
At approximately 14:20, Worker 1 was seated on a roof beam approximately 16.8 m (55 ft.) in elevation conducting bolt-up duties. Investigators determined that at this point, Worker 1 was not connected to a fall protection system. Worker 2 was working from a boom-supported elevating lift one bay over from where Worker 1 was working. (See Figure 2).

**Figure 2:** North side of steel structure, showing where Worker 1 was positioned.

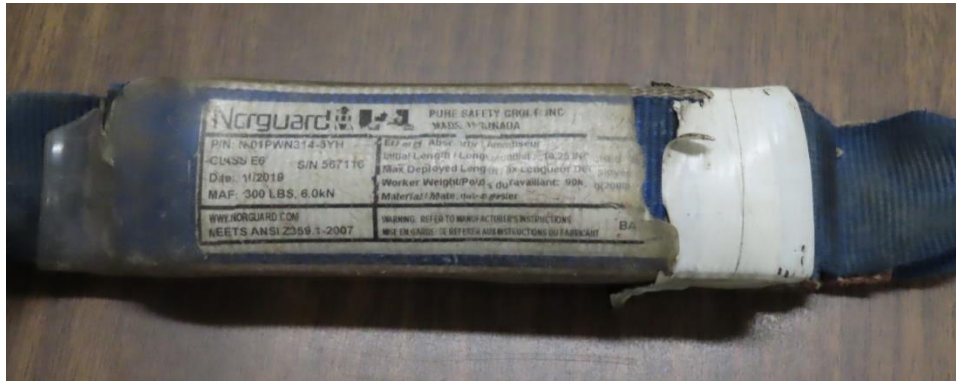
The shock-absorbing lanyard worn by Worker 1 on the day of the incident was damaged and should have been removed from service. The lanyard was in poor condition and had been taped at the end. (See Figure 3). This was in contravention of the manufacturer's instructions, which required immediate removal from service if defects or damage is found. Supermétal's occupational health and safety (OHS) program required workers to check the condition of their personal protective equipment (PPE) daily; however, Supermétal was also responsible under the Occupational Health and Safety Regulation for ensuring compliance with that provision. The fact that the fall protection equipment was in poor condition was not causal to the incident because Worker 1 was not connected to the lifeline.

*Figure 3: Damaged shock-absorbing lanyard.*

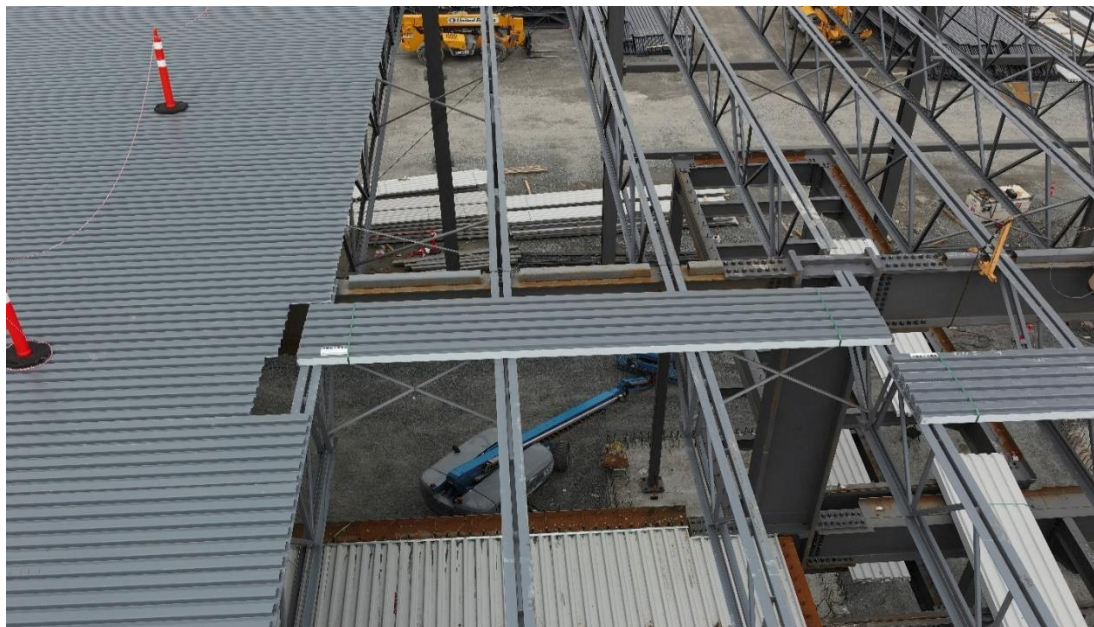
The investigation identified areas on the roof that did not have a continuous horizontal lifeline for workers to connect to while traversing the beams. These areas consisted of void spaces or gaps where workers had to navigate an area without the ability to use any fall protection. This exposed workers to serious potential risk. (See Figure 4.)

*Figure 4: Void space that exposed workers to potential risk.*

The lack of a continuous lifeline did not contribute to the incident.

The third level of the steel-frame warehouse, where Worker 1 was positioned at the time of the incident, had a horizontal lifeline system in place. However, the system had gaps where workers had to unclip from the lifeline to traverse beams. These deficiencies posed risks to workers on the third level but did not contribute to the incident.
